Advanced Turbine Technology

ATTAP

1990 Annual Report

DOE/NASA 0336-3
NASA CR-189142
EDR 15593

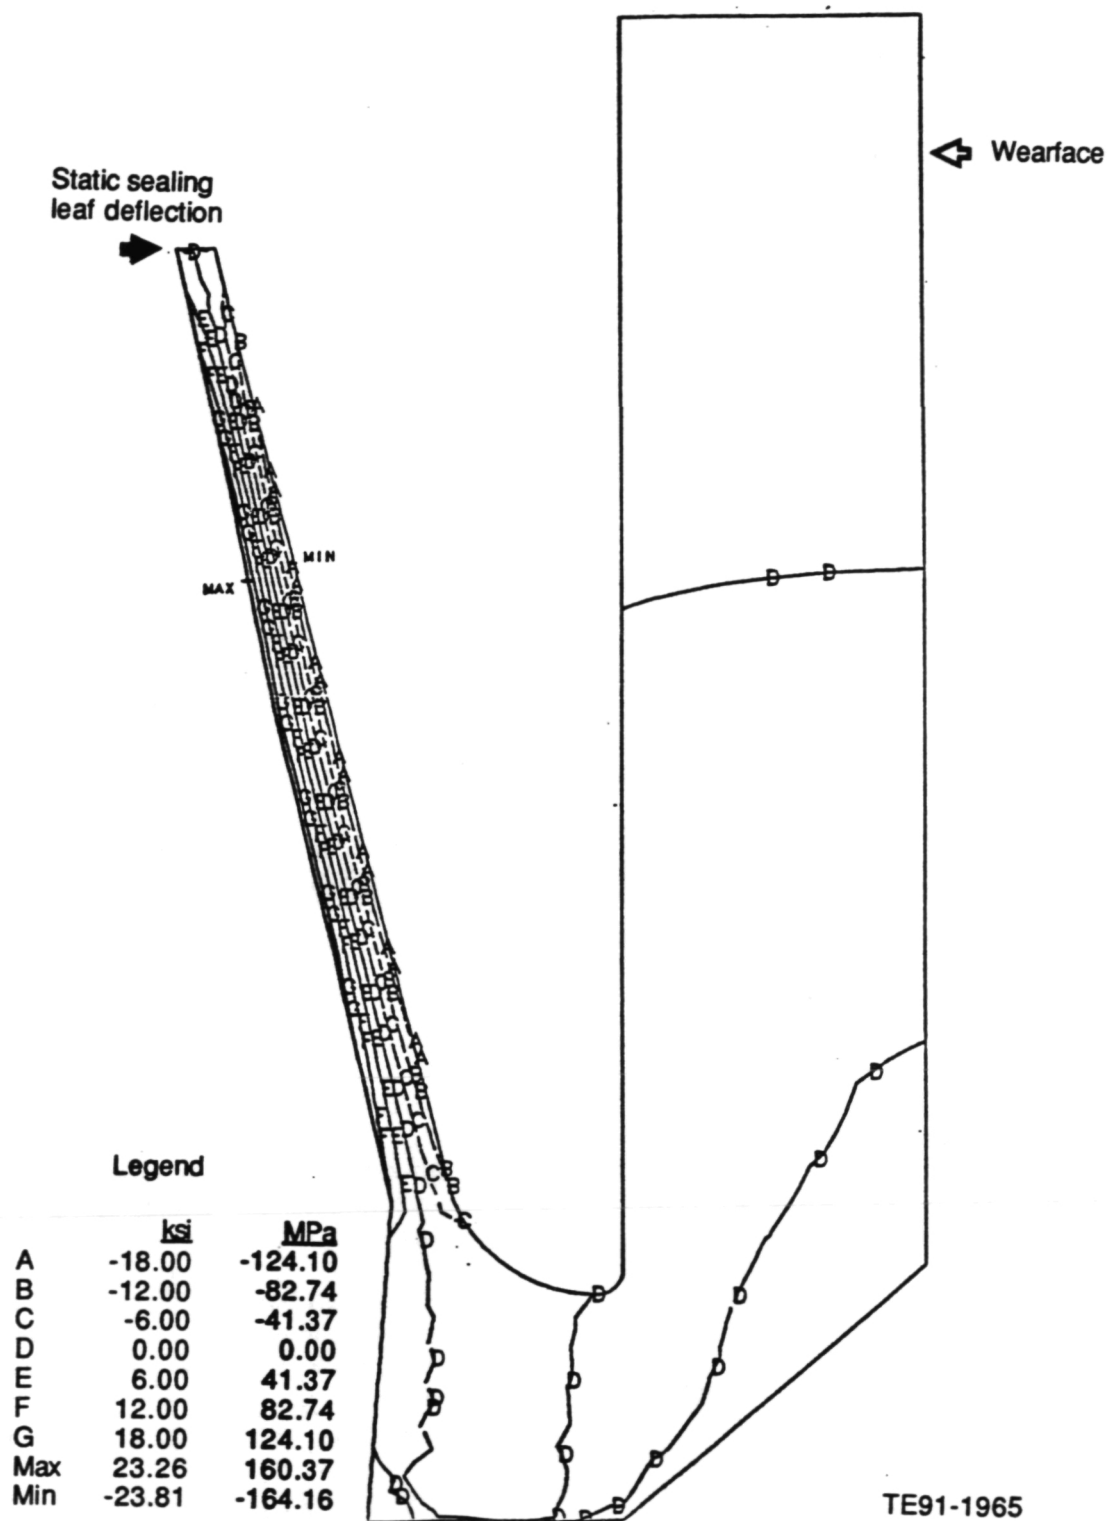
Figure 5. Polyimide-graphite fiber regenerator cold side seal with pressure and leaf installation deflection.

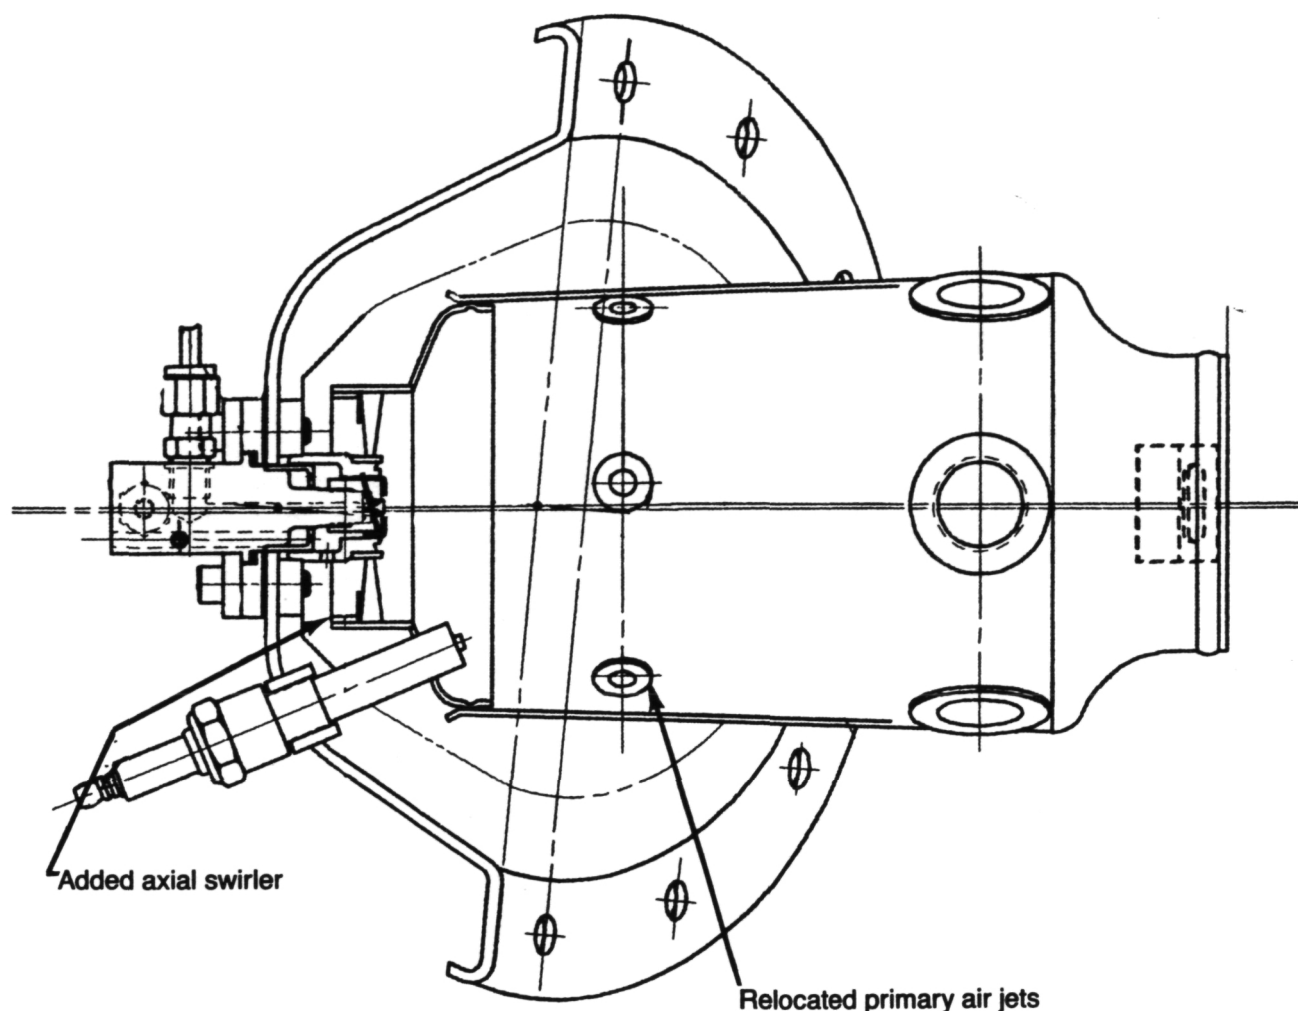
Figure 6. AGT-5 test-bed enhanced stability diffusion flame combustor.

In the initial attempt to reduce CO and HC emissions so that all three emissions standards could be met on methanol fuel, the standard combustor was modified to improve its combustion stability. Thumbnail louvers in the combustor dome were replaced with an axial swirler, and the primary air admission jets were relocated to a plane further downstream on the combustor body. The revised burner was named the enhanced stability combustor and is depicted in Figure 6. The modifications were made to significantly increase the recirculating mass flow rate in the combustor primary zone and to eliminate combustion instability as a potential cause of high CO and HC emissions when burning methanol.

The enhanced stability combustor was installed in an AGT-5 engine and tested on an engine dynamometer stand at the General Motors' Technical Center. Emissions were measured at steady-state operating conditions over a range of gasifier speeds. Atomizing air pressure drop was also varied in the test. The fuel was M85, a mixture of 85% methanol and 15% gasoline by volume. Emissions results are compared to those of the standard combustor in Figure 7. As can be seen from this figure, the modifications had the opposite of the intended effect. NO_x emissions were reduced, but CO and HC emissions increased with respect to the standard combustor. This result indicated that combustion instability was not the cause of

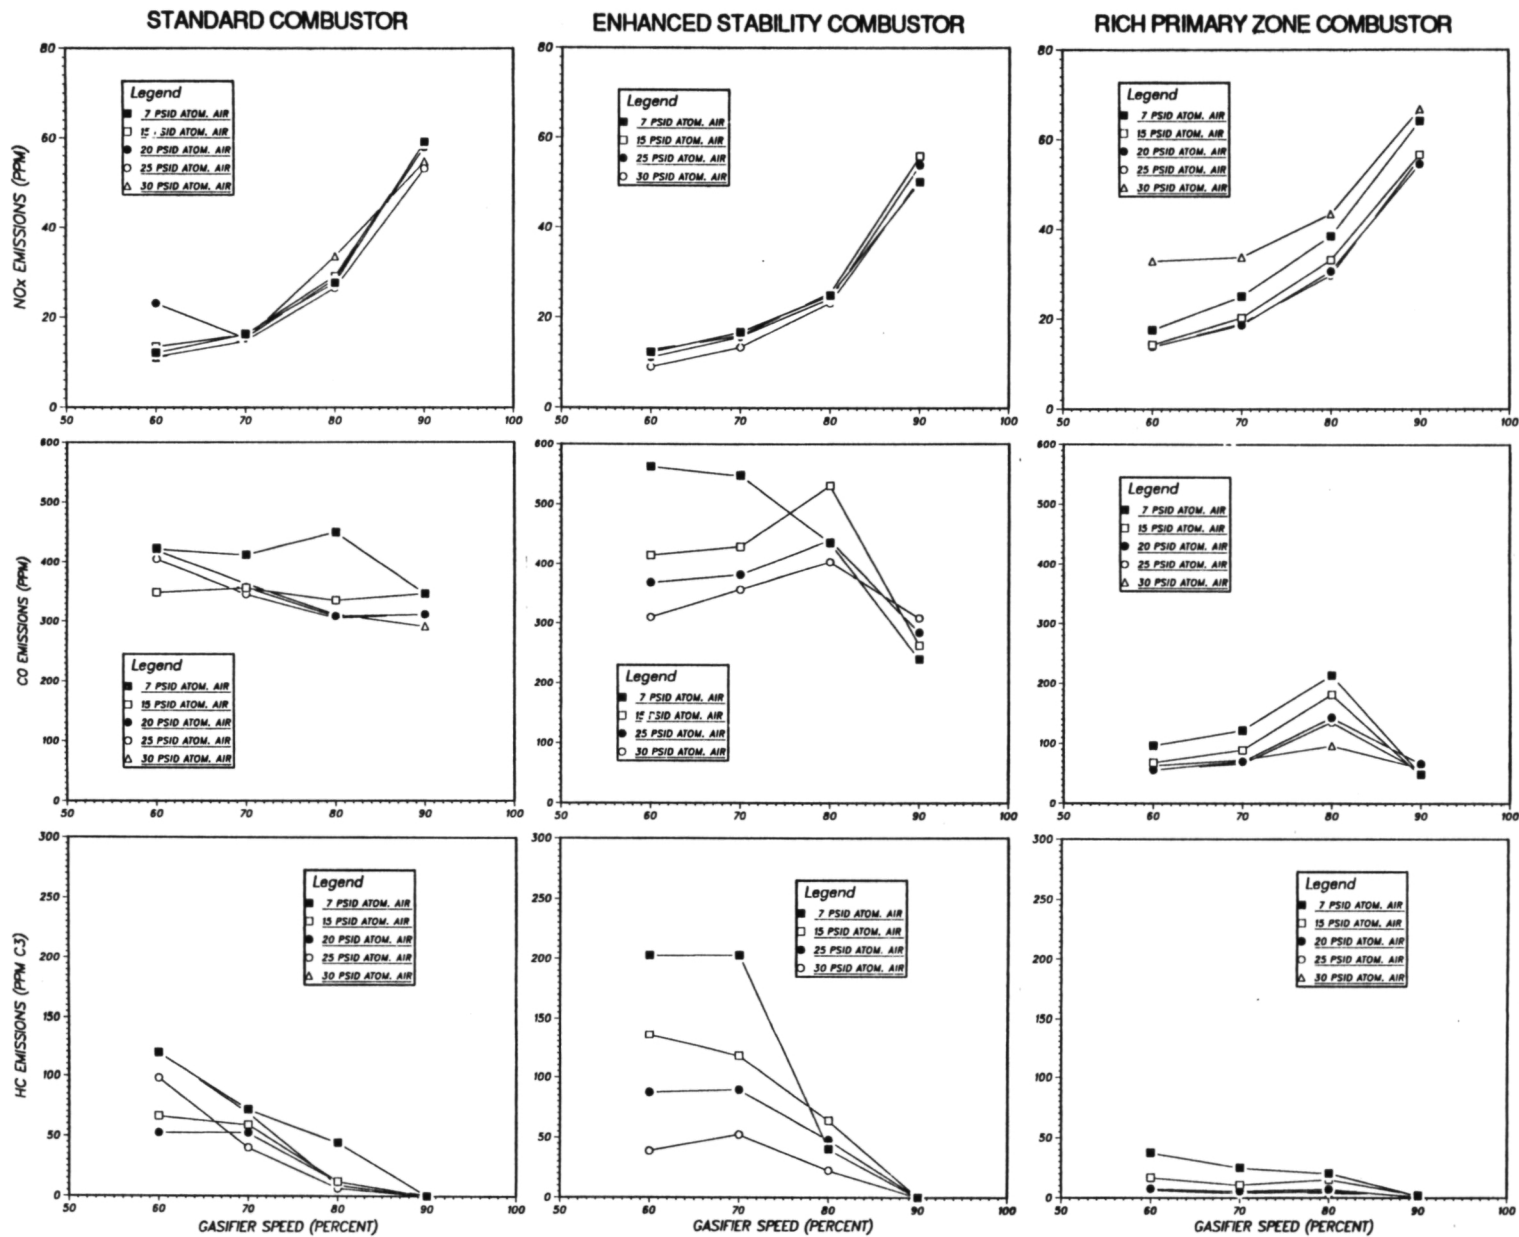
Figure 7. Comparison of measured emissions from standard, enhanced stability, and rich primary zone combustors.

The next modification tested was designed to have less air in the primary zone than the standard combustor and was, therefore, called the rich primary zone combustor. The only difference between the two burners is that thumbnail louvers on the standard combustor dome are blocked in the rich primary zone combustor as shown in Figure 8. Emissions results with the rich primary zone combustor are shown in Figure 7. Very significant reductions in CO and

HC were achieved without an increase in NO_x . In fact, emissions were low enough to meet current Federal standards if converted to a gm/mi basis. However, this result was not obtained over the formal urban driving cycle since the test was performed on an engine dynamometer stand under steady-state conditions.

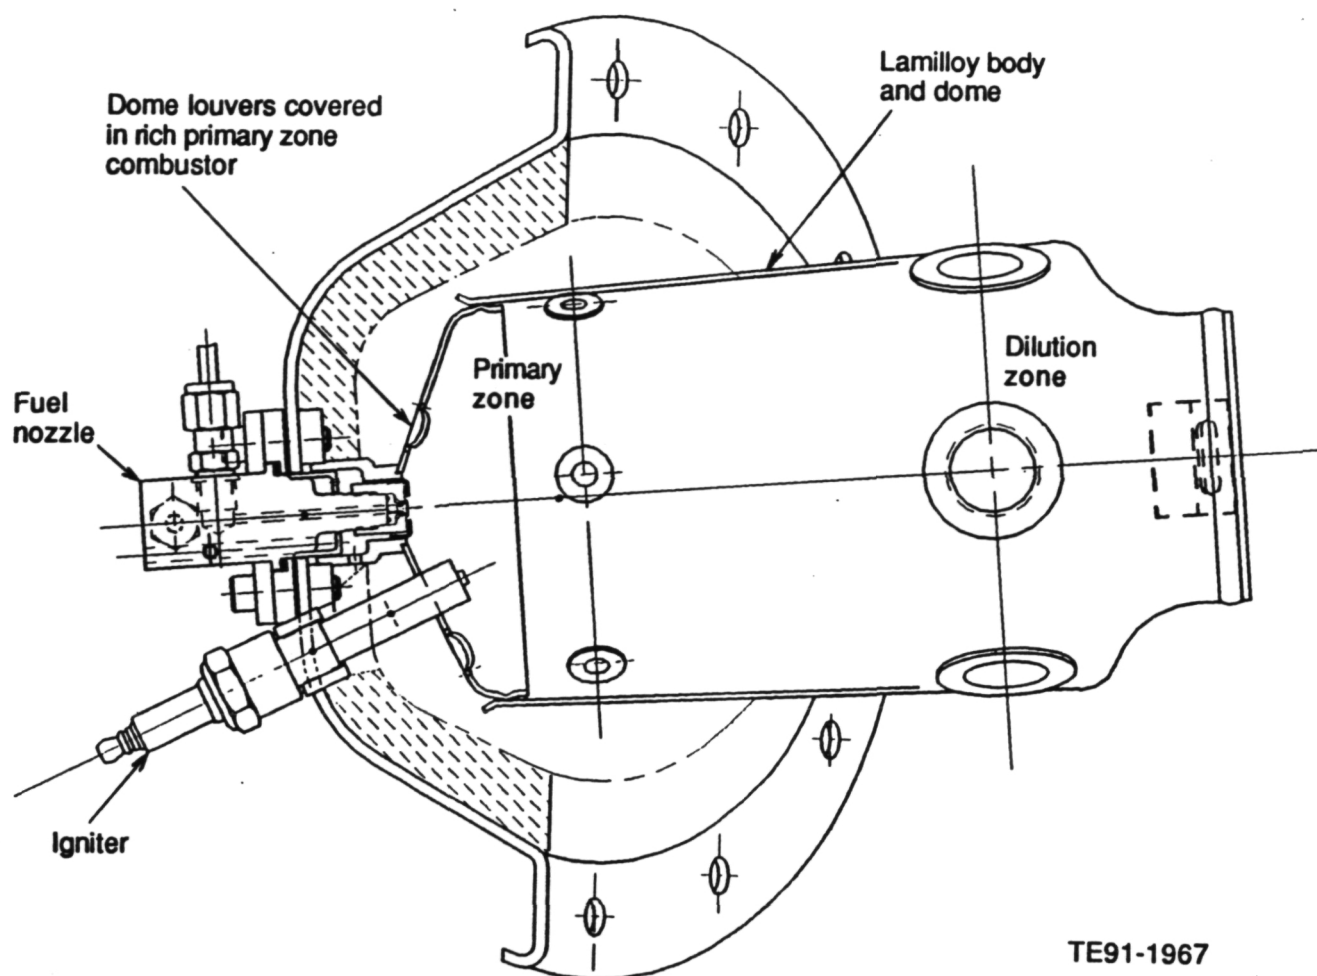
Figure 8. AGT-5 test-bed rich primary zone diffusion flame combustor.

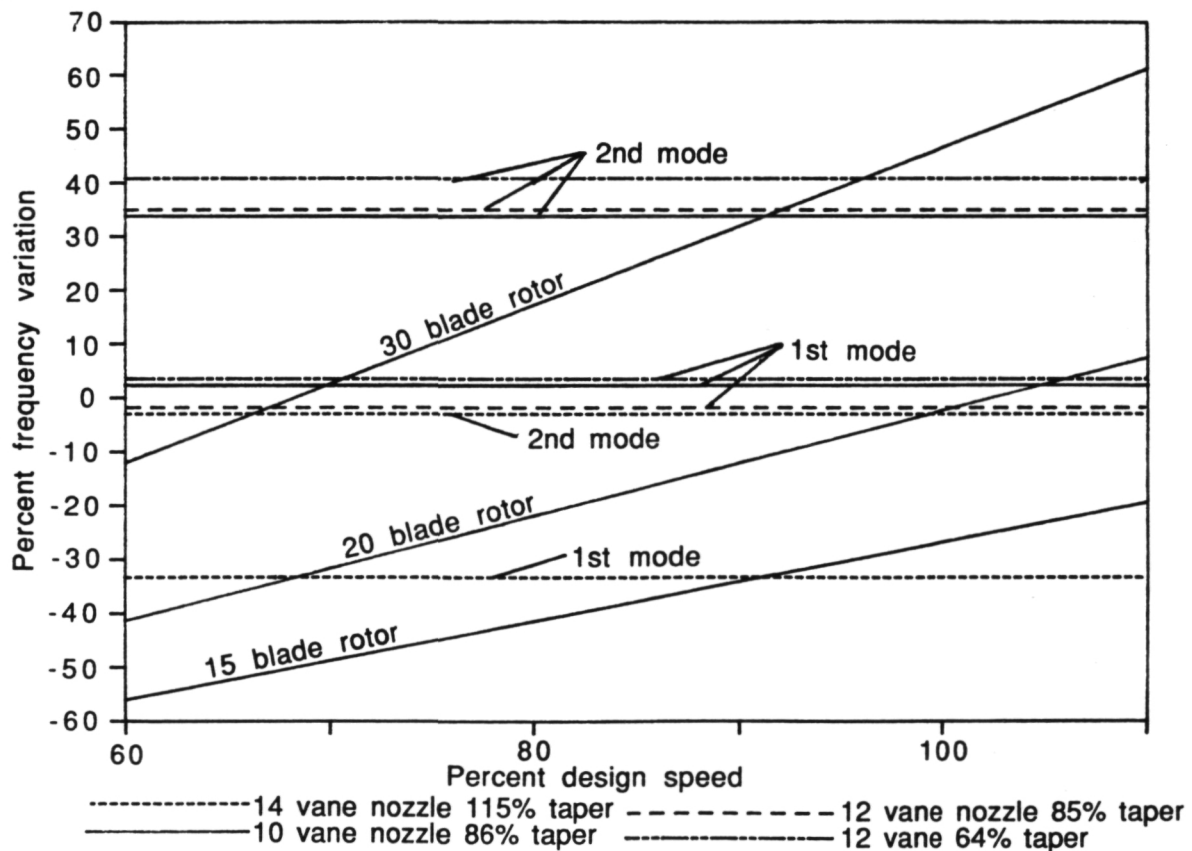
Figure 12. Campbell diagram--integral vane/hub platform aerodynamic designs.

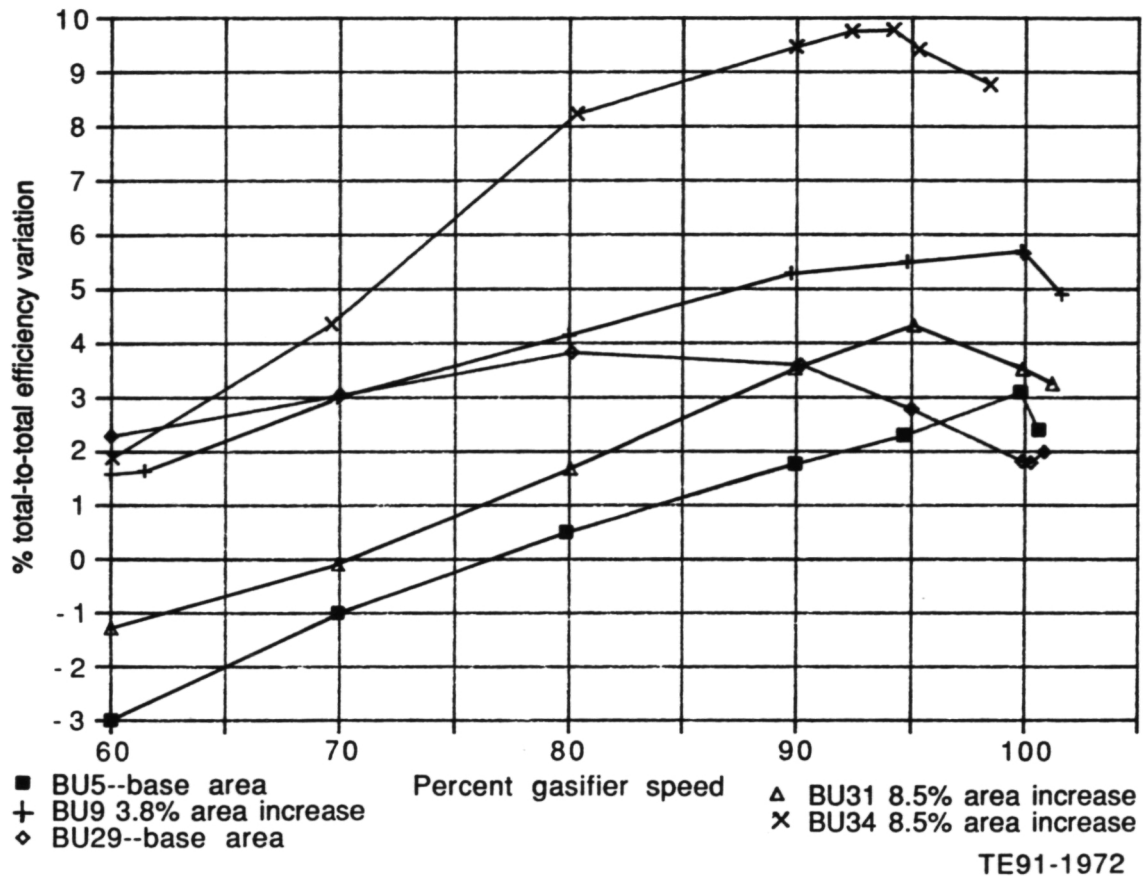
Figure 13. Gasifier rotor flow area effect on total-total stage efficiency.

A series of engine builds was completed in an attempt to enhance the gasifier turbine stage efficiency and increase the engine airflow. The gasifier rotor tip diameter was increased from the standard area (BU29) to a tip diameter with a 8.5% increase in throat area (BU31). The large diameter rotor had a 2 point increase in stage efficiency at 100% gasifier speed. At the low speed conditions, the efficiency of the large rotor was 1.5 points lower than the small diameter rotor (see Figure 13).

At the low speed conditions, a free vortex model of the larger tip diameter rotor (a low reaction stage) calculated a relative rotor hub inlet Mach number of 0.48 and a relative exit Mach number of 0.41. The smaller tip diameter rotor (a higher reaction stage) had a calculated relative inlet Mach number of 0.465 and the exit relative Mach number of 0.444. The hub surface velocities were calculated for each of the above cases and as expected the surface velocities on the suction surface of the large tip diameter rotor (low reaction stage) dropped off at a greater rate than the suction surface velocities of the small diameter rotor (high reaction stage). The surface velocity comparison is illustrated in Figure 14. The adverse decrease in surface velocities on the large tip diameter rotor (low reaction stage) is suspected to induce separation, thereby lowering stage efficiency.

The gasifier efficiencies from a number of previous engine builds were also plotted on Figure 13. It should be noted that engine operating

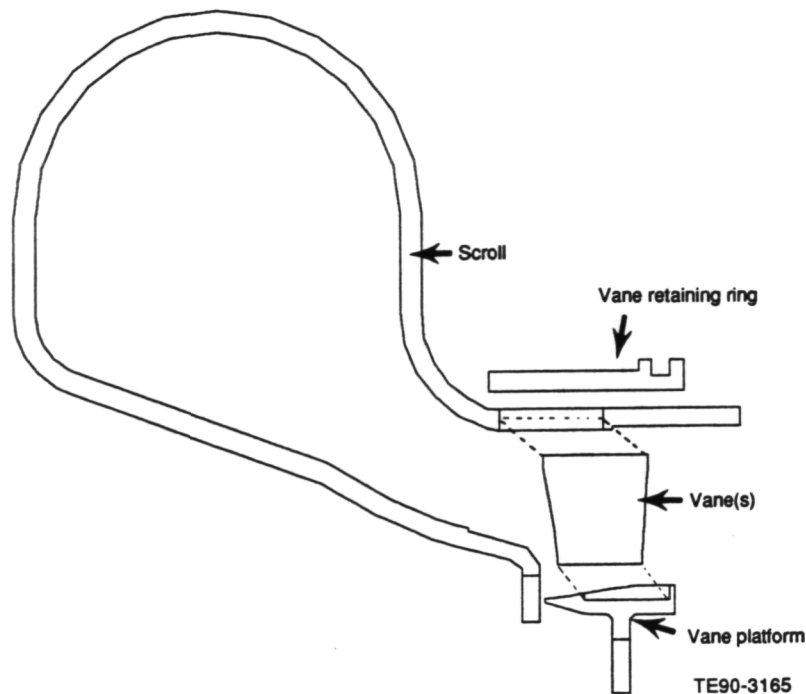
Figure 15. Gasifier turbine static structure.

In addition to those ceramic components identified as requiring considerable development under ATTAP (i.e., the gasifier turbine assembly, regenerator disks, and engine insulation) the engine assembly also includes a ceramic combustor assembly and selected ceramic power turbine components (rotors and shrouds). The gasifier turbine static structure, shown in Figure 15, consists of a scroll that guides the gas flow from the combustor to the turbine vane (nozzle) row. This row consists of loosely mounted vanes that act to accelerate the flow to rotor inlet conditions; a retaining ring surrounds the scroll outer shroud and covers slots within this shroud through which the vanes are inserted into the gas path. A vane platform forms the inner gas path boundary and positions the hub end of the vanes within machined pockets contained in this structure. The gasifier turbine rotor completes the gasifier turbine assembly. The gasifier turbine static structure is mounted to the engine structure by a combination insulating/locating subassembly, which inhibits heat flow from the gas path into the engine structure. Cross key features are utilized to accu-

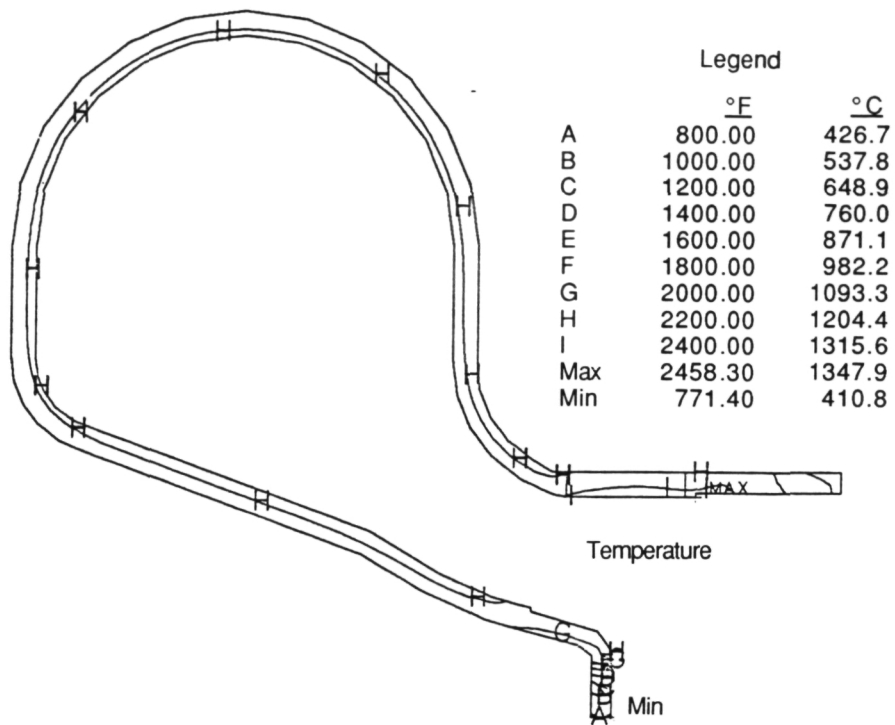
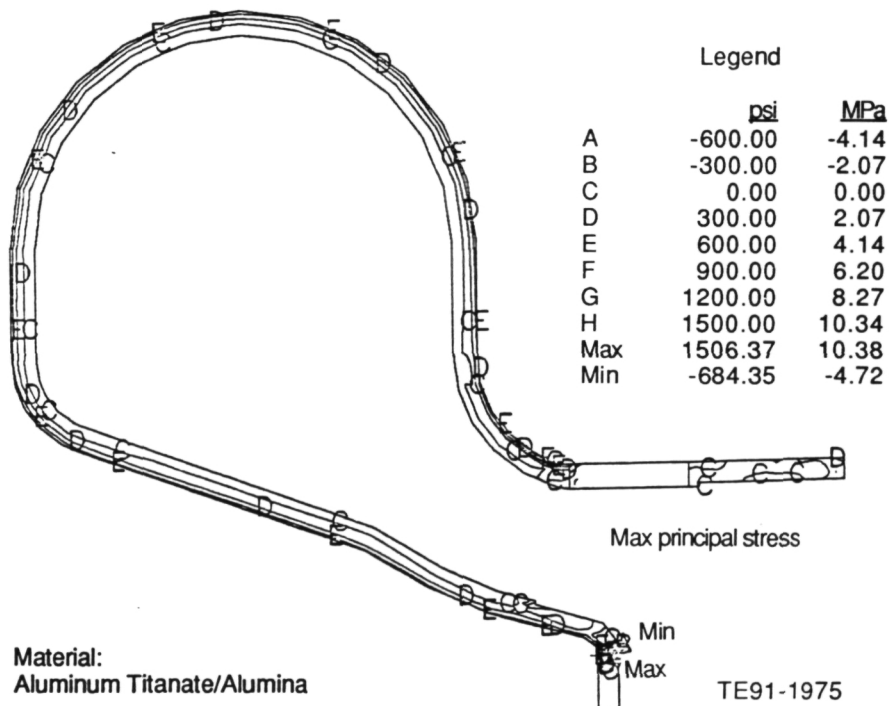
Figure 17. Temperature and maximum principal stress in scroll with vane slots; maximum power.

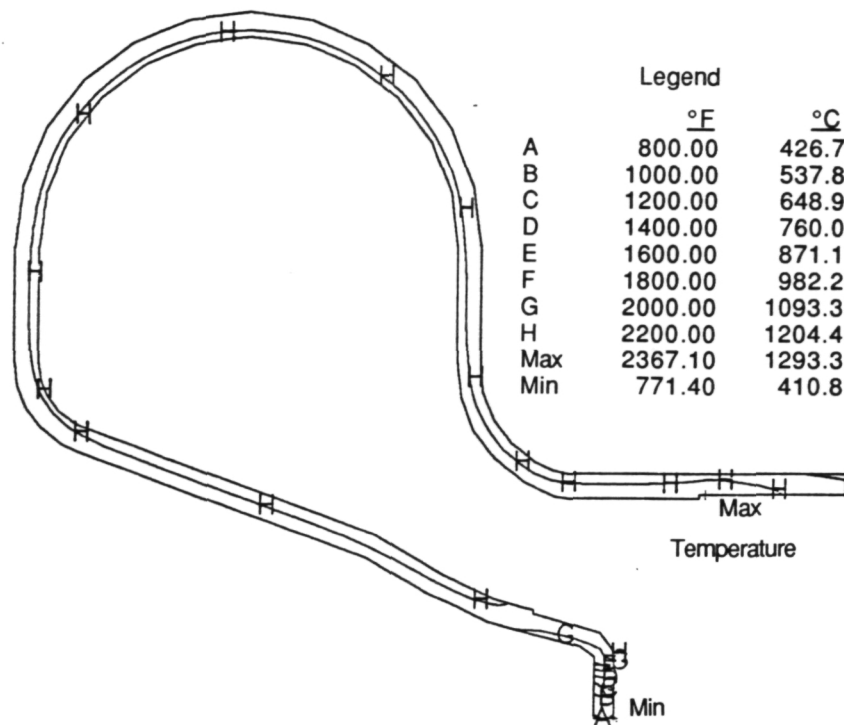
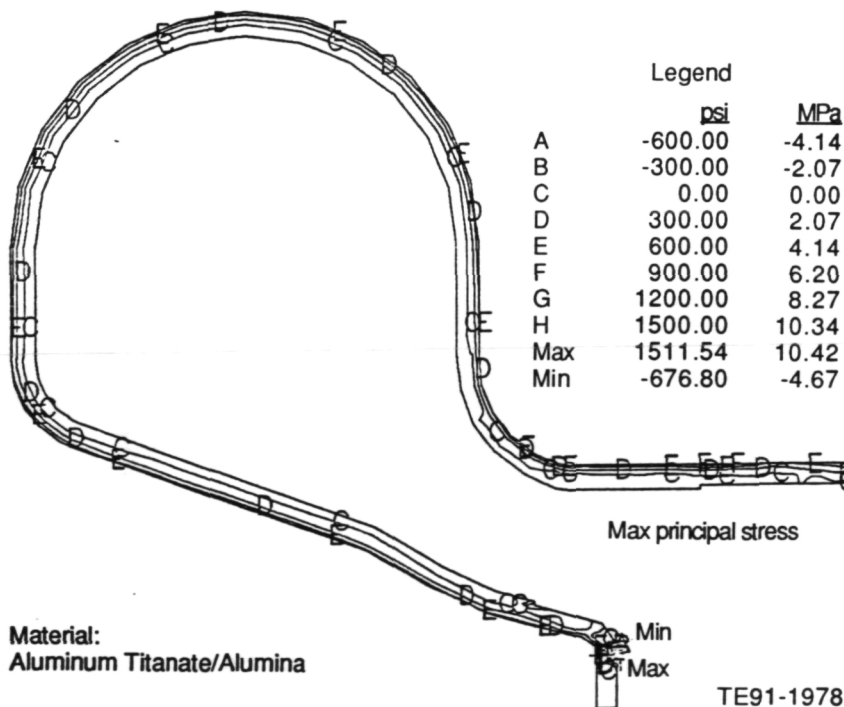
Figure 20. Temperature and maximum principal stress in scroll without vane slots; maximum power.

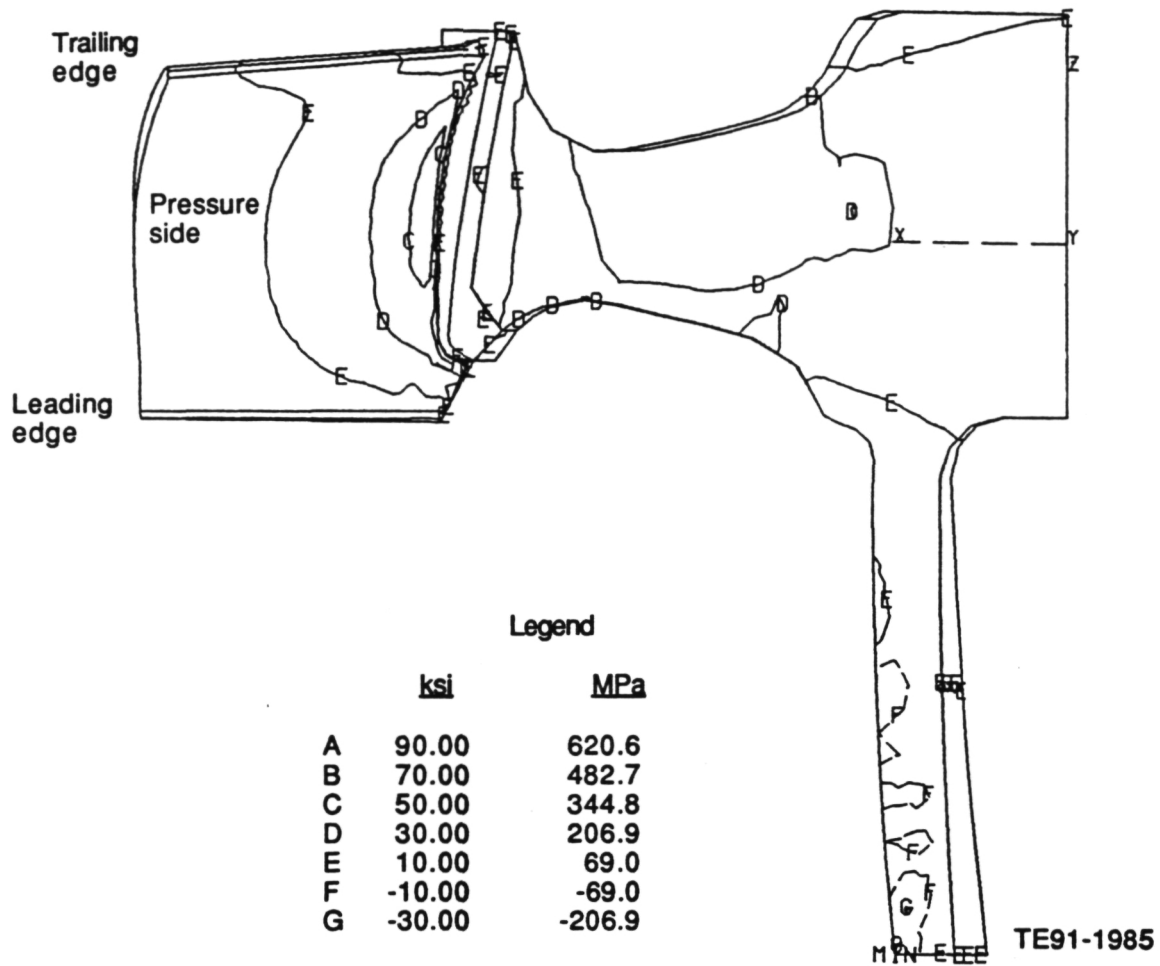
Figure 27. 3-D calculated maximum principal stresses, 15-airfoil rotor, SN252 silicon nitride, transient acceleration condition.

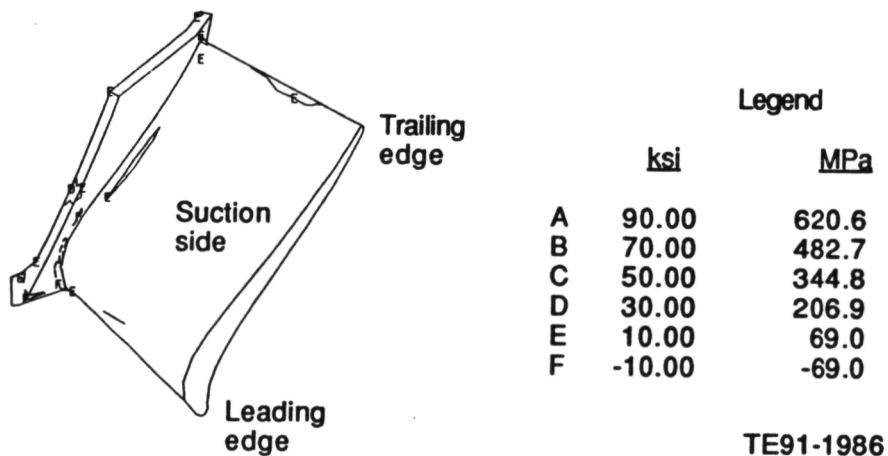
Figure 28. 3-D calculated maximum principal stresses, 15-airfoil rotor, airfoil suction side, SN252 silicon nitride, transient acceleration condition.

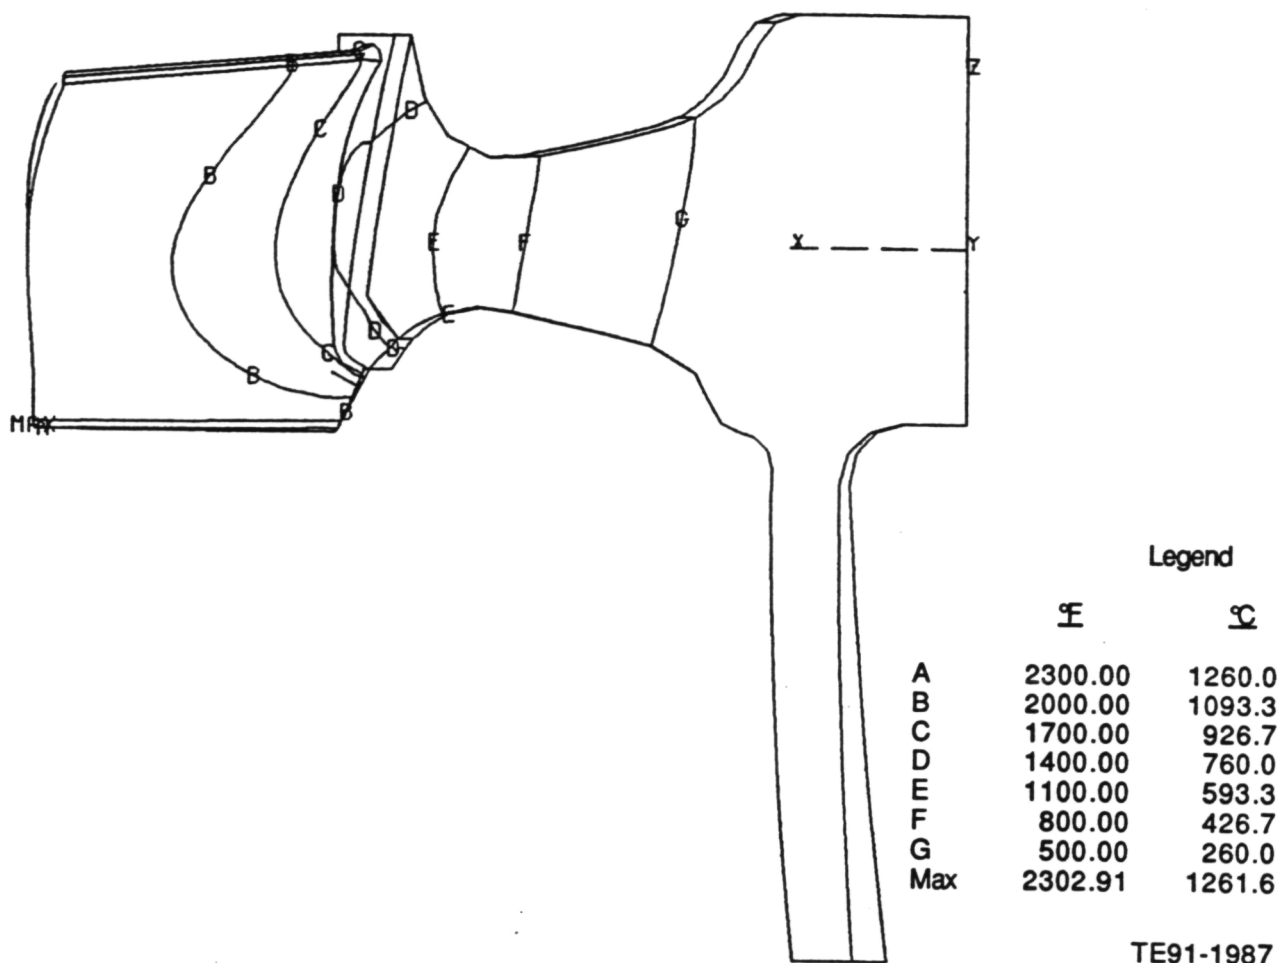
Figure 29. Calculated thermal gradients, 15-airfoil rotor, SN252 silicon nitride, transient acceleration condition.

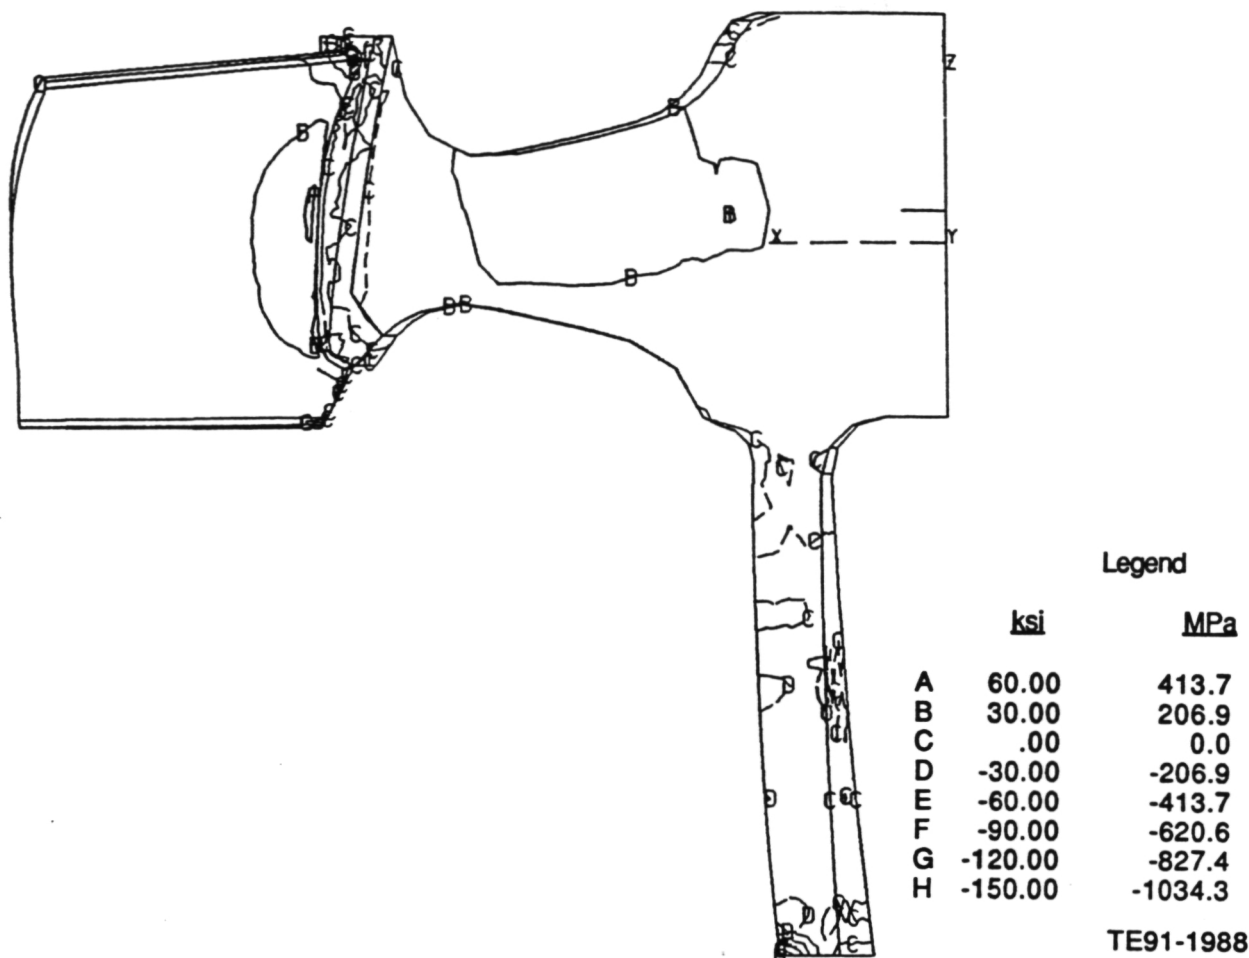
Figure 30. 3-D calculated radial stress components, 15-airfoil rotor, SN252 silicon nitride, transient acceleration condition.

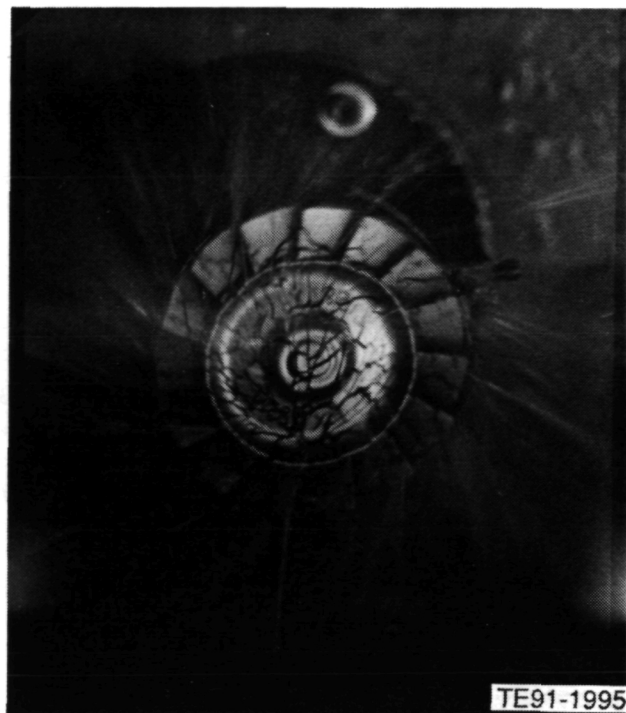
Figure 37. CBO HIPed α -SiC gasifier rotor (FX78517) burst, $N_1 = 79,900$ rpm.

Figure 37 shows the CBO rotor (FX78517) at the moment of burst, which occurred just under the design proof speed of 80,000 rpm. A possible location of the failure origin could be in the thin web area of the wheel or in the blade fillet area. The photo was inconclusive as to the exact location. Figure 38 displays CBO rotor S/N FX78519, which burst at 31,000 rpm. The photograph clearly shows the rotor breaking into two distinct sections (evidence of an internal flaw). A large section of the rotor was recovered and is shown in Figure 39. The defect in the rotor is the circular area (see arrow) in the thick area of the rotor hub. The smaller, lighter colored circle within the outer circle

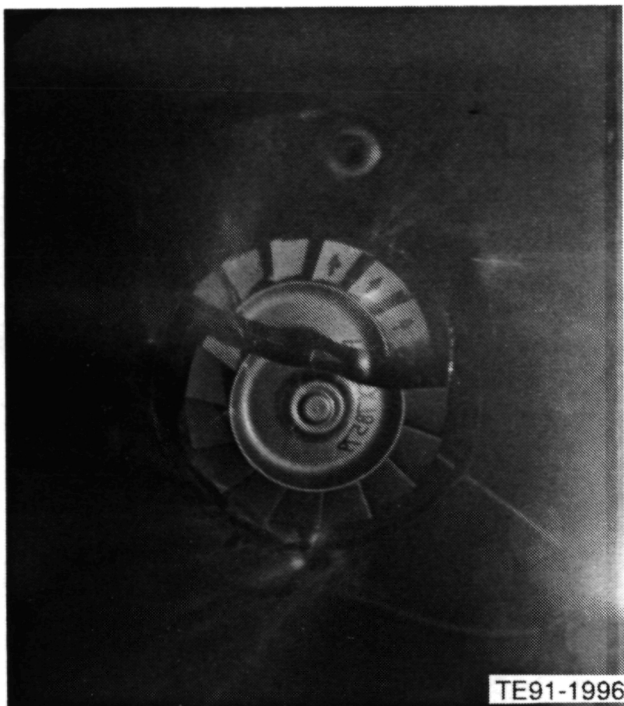
Figure 38. CBO HIPed α -SiC gasifier rotor (FX78519) burst, $N_1 = 31,000$ rpm.

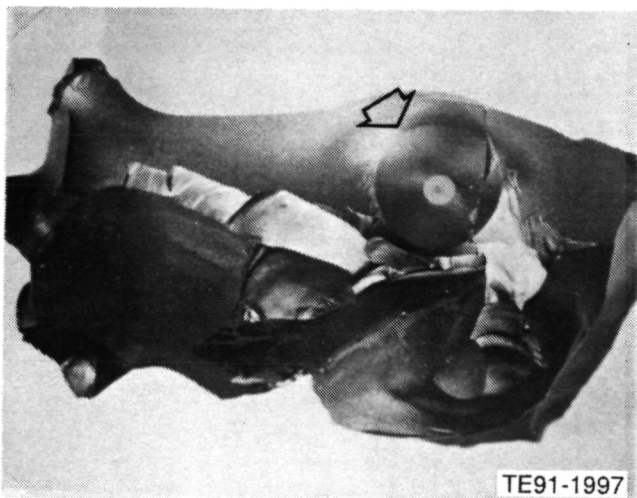
Figure 39. Section of CBO HIPed α -SiC burst rotor (FX78519). Initial failure site is circular crack (see arrow).

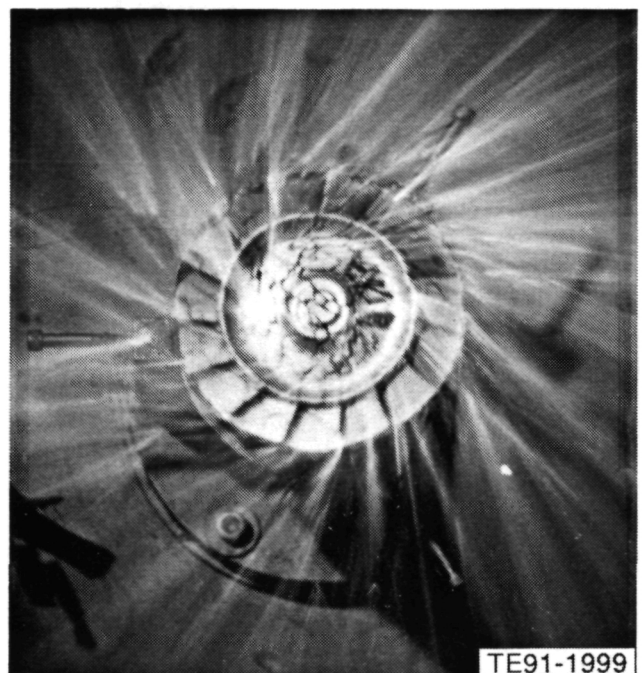
Figure 41. CBO HIPed α -SiC rotor (FX78528) burst, $N_1 = 79,600$ rpm.

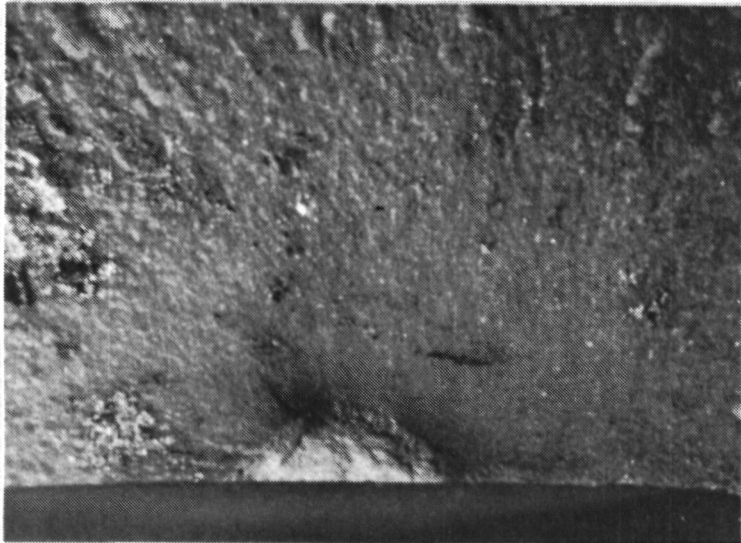
Figure 44. Failure origin of GTE rotor (S/N 576.)

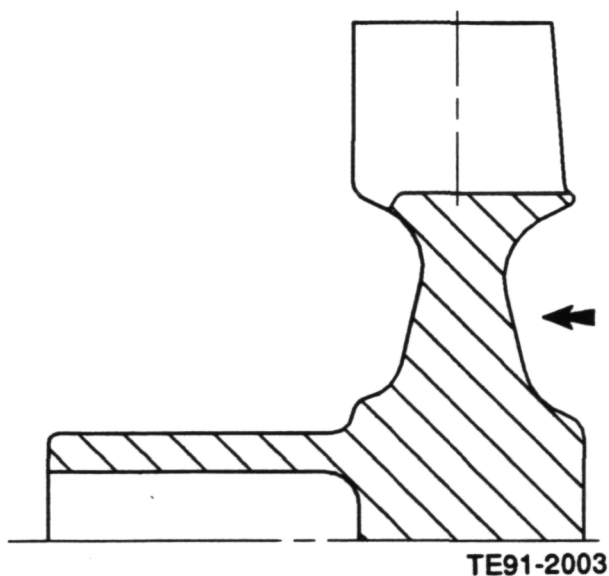
Figure 45. Failure site location of GTE rotor (S/N 576.)

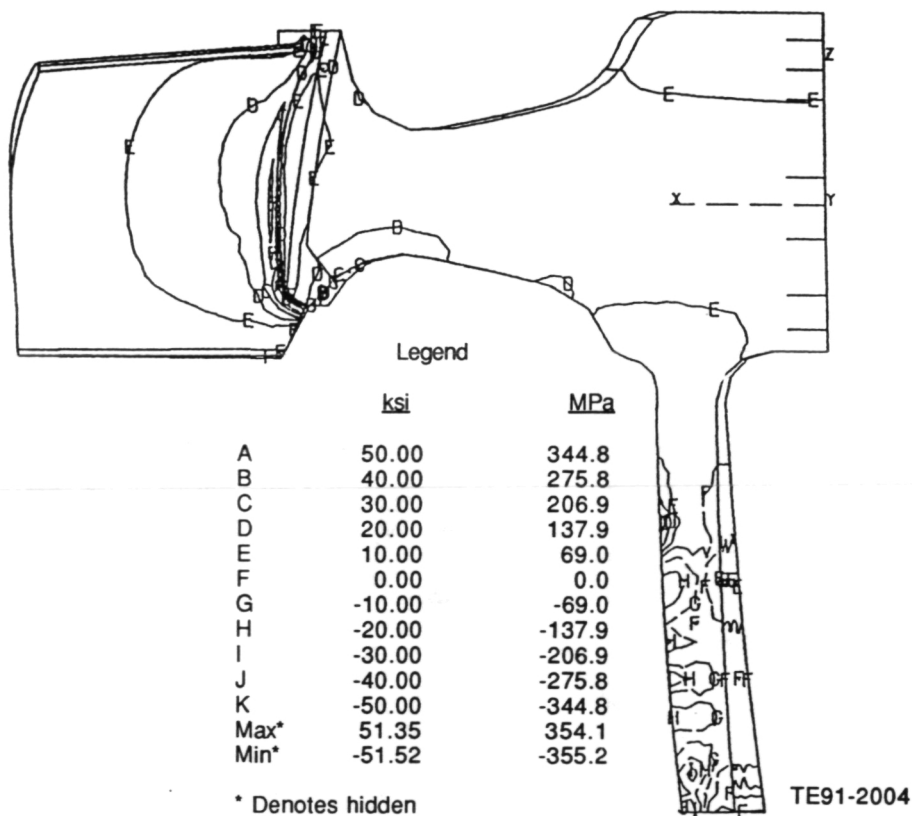
Figure 46. 3-D calculated maximum principal stress distribution for GTE PY6 rotor - room temperature spin condition.

measuring the mirror surface area. Figure 46 shows the 3-D calculated maximum principal stress distribution for a room temperature spin condition of 100% N₁ and a corresponding stress at the region of failure of 138 MPa (20 ksi). As stress is a direct function of the square of the

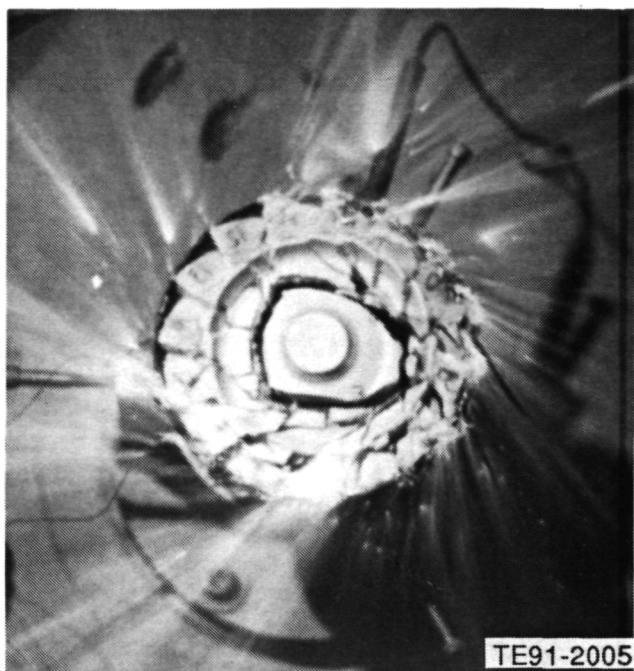
Figure 47. GTE rotor (S/N 656) at moment of burst, $N_1 = 66,800$ rpm.

GTE's rotor (S/N 656), which failed at 66,800 rpm, is shown in the burst photo in Figure 47. The failure origin, shown in Figure 48, was on the forward face of the wheel in the thin cross section area of the hub (see Figure 49). The flaw is believed to be the result of machining damage. The approximate stress at the failure site was calculated (using the mirror surface) to be 172 MPa (25 ksi). Using Figure 46 as a reference, the resulting stress in the fracture origin location would be approximately 177 MPa (25.6 ksi) when accounting for the rotational speed correction, again consistent with that calculated from the mirror surface area.

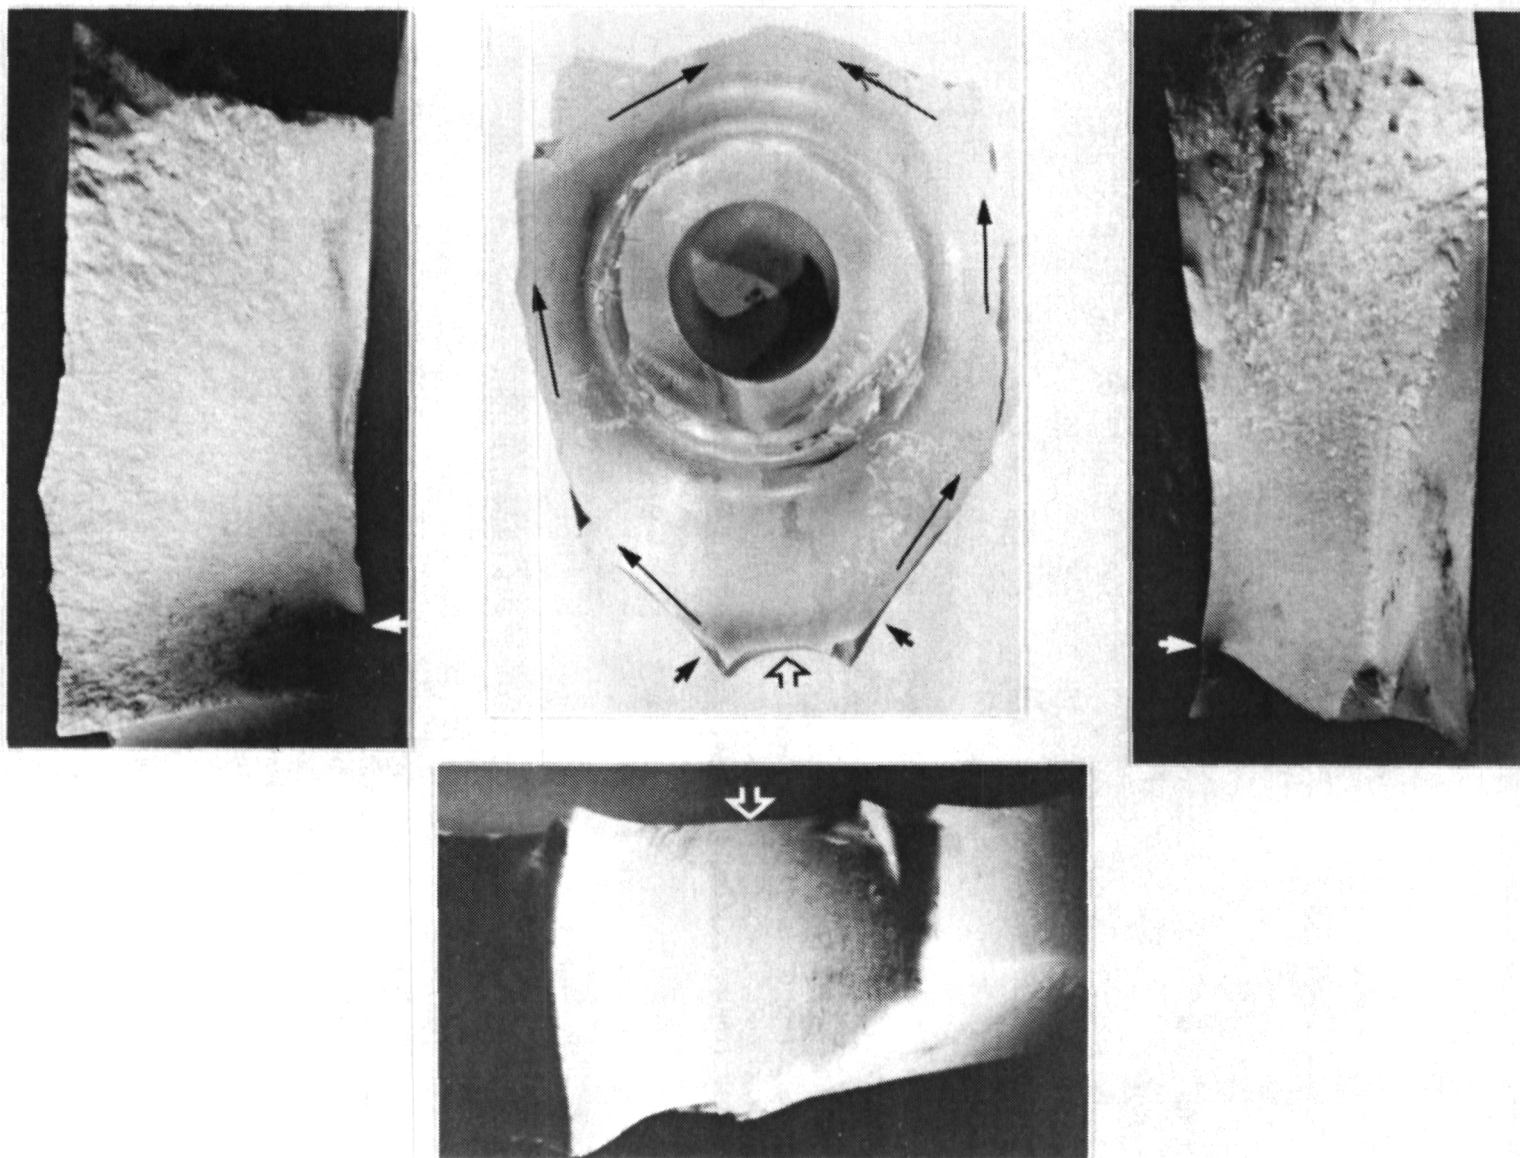
Figure 48. Failure origin of GTE rotor (S/N 656.)
